Manhole Inspection Summary

Manhole # S41C__057MH

Inspection ☐ Is Incomplete Rating: **3) Fair**

Location Address: **s. central ave**

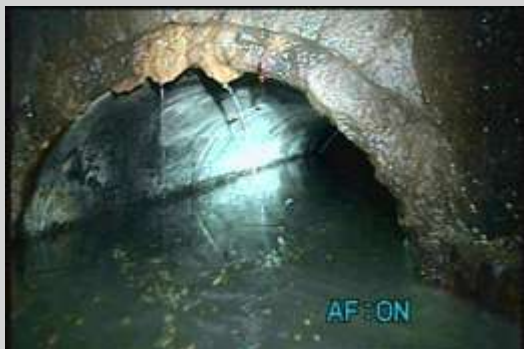
6 O'Clock Inflow

21 in. Circular Gravity Sewer
Pipe In @ 6 O'Clock

Pipe Height: 0 (in.) Direct

Pipe Material: **Clay** ☐ Pipe Lined

Infiltration: **None** Pipe Seal Cond: **Unknown**
